*Condition Assessment for Mining  
Reliability, and Asset Optimization*

## **New ASTM Standard for Mill and Kiln Ring Gear Cleaning and Inspections**

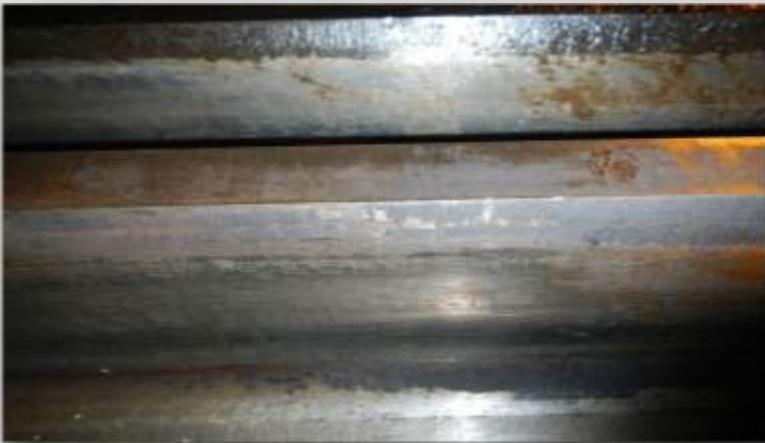
FIGURE 6: Gear flank in good condition

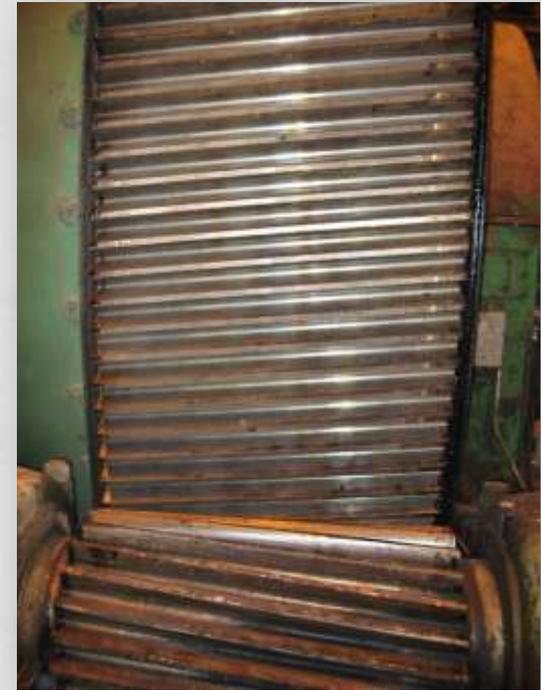
FIGURE 10: Clean Ring Gear and Pinion

- Over the years, ring gear cleaning, that use high viscosity, asphaltic based lubricants has become something to be avoided at all costs.
- There is now a ring gear cleaning procedure that not only simplifies the cleaning process, but reduces numerous hours of labour. The exception to this is if the lubrication is an oil bath system. In this case, no cleaning is required.
  - The actual time of cleaning a ring gear is under an hour.
  - There is no need to wipe the gear teeth down after by hand to remove residue as in Magnetic Particle or Dye Penetrant inspections.
- The ability to fully visualize the gear teeth is critical for a true gear inspection or audit. (Fig. 10)

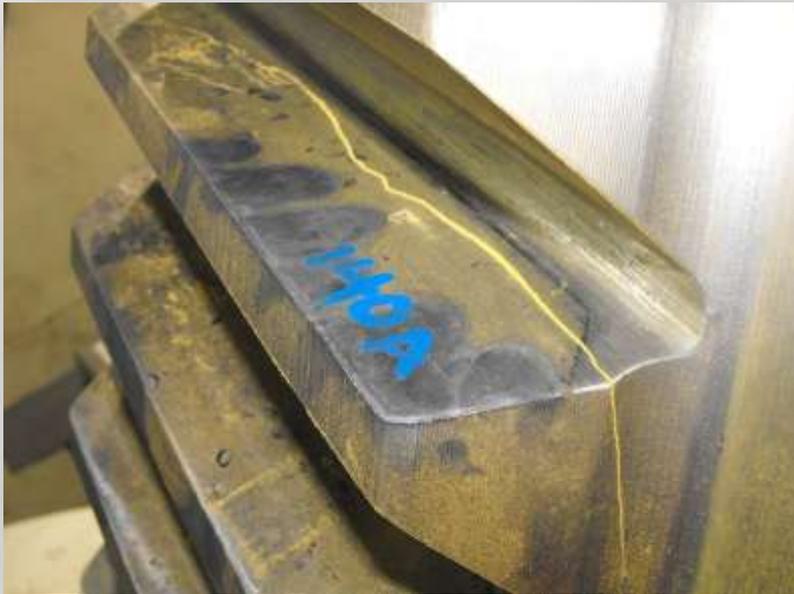
FIGURE 15 – Crack on a Gear Flank

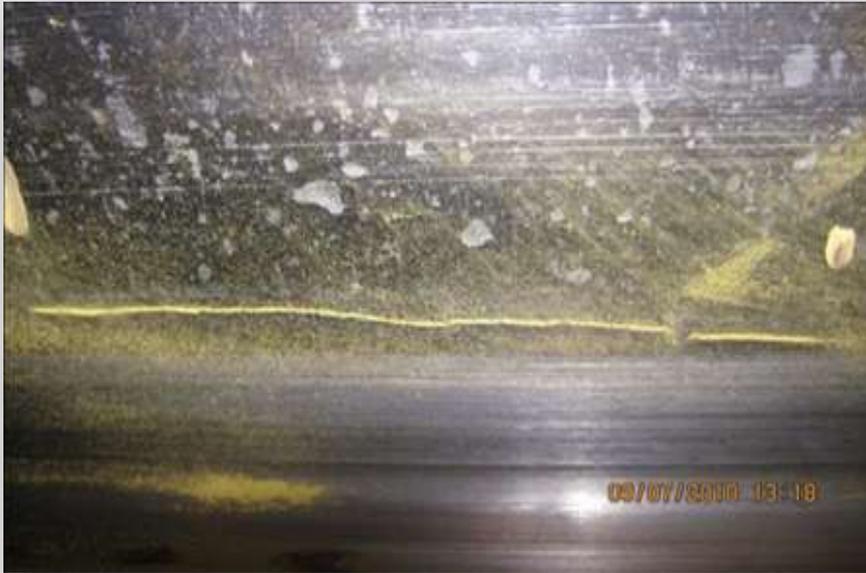
FIGURE 17 – Crack on tooth 244A - near the root – could not be visualized

- An excellent example of the benefits of this method is shown on the following page. The client requested an inspection on a 34' diameter ring gear.
- Once again, the gear teeth are visually inspected as the teeth are scanned. On tooth 244A, (Figure 17) E2905 detected two cracks that could not be visualized.
- The next step was to size the cracks. Utilizing Alternating Field Current Measurement (ACFM), both cracks were sized. The larger crack, was sized at 3.63" L x .68" deep.

- The sizing took less than three minutes.
- To further validate the characteristics of the crack, MT was used to visualize the crack and to document it.
- Moving forward, these cracks can be monitored through the inspection hole, on the gear guard, in less than fifteen minutes.
- Typically this mill would go down for scheduled maintenance four times a year, thus providing a comfort level to the client that any propagation of the cracks can be monitored.
